**Flood Control Project Maintenance  
Levee Inspections**

**Fall 2018 Levee Maintenance Deficiency Summary Report**

**Flood Control Project Maintenance  
Levee Inspections****LMA District Cover Sheet****Fall 2018 Levee Inspection Results****Reclamation District No. 0501 Ryer Island**

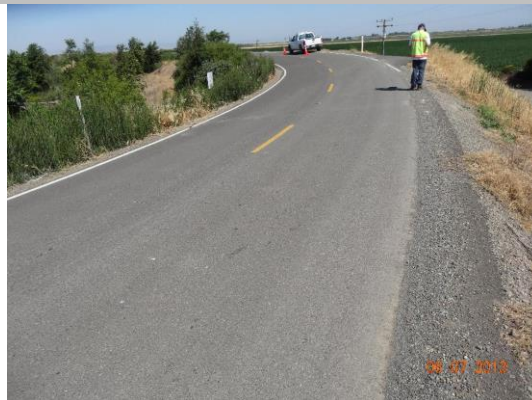
Photo 1 of 3 : UCIP\_FA\_2018\_47050\_33371.jpg

UCIP Comments: Dense vegetation limits the inspector's visibility to identify signs of pipe failure (leaks) through the slope. Recommend removing vegetation along pipe alignment to conduct proper inspection of structure and appurtenances.

Overview of levee crown at crossing.

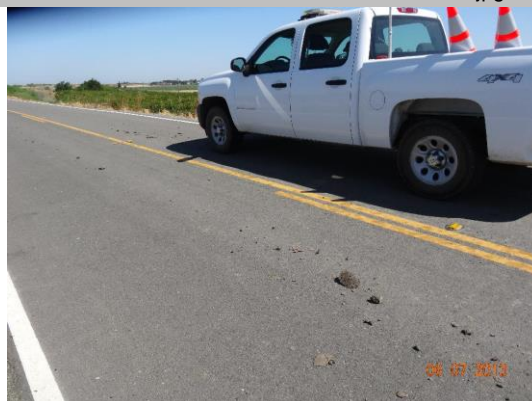
Photo 1 of 3 : UCIP\_FA\_2018\_32537\_58989.jpg

Comment Code					
Inspector Comment					
FS_ID:32537 DS_ID:21044 EP_NO: N/A Repair Type: Non-Urgent Crossing Status: Found UCIP Comments: Dense vegetation limits the inspector's visibility to identify signs of pipe failure (leaks) through the slope. Recommend removing vegetation along pipe alignment to conduct proper inspection of structure and appurtenances. FIELD_STRUCT_DESC: 14-inch coated steel irrigation siphon pipe through the levee, 6.2 feet below the crown. Siphon breaker on the waterside (WS) shoulder. (Plans to replace a section of an existing 14-inch pipe in the levee authorized under Permit No. 13937, 19 - Lewis Nixon Company). [Additional Reference(s): DWR Levee Log, 2005. USACE Sacramento O&M Manual 105, April 1959, (HLM 2.6)]. FS Date: 6/7/2013

View of levee crown--narrow road.

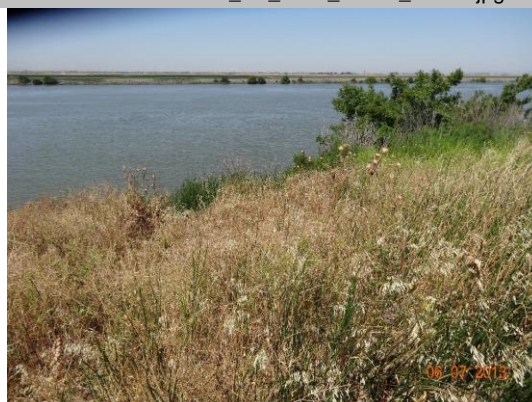
Photo 2 of 3 : UCIP\_FA\_2018\_32537\_58990.jpg

Photo taken just downstream of crossing looking at waterward side.

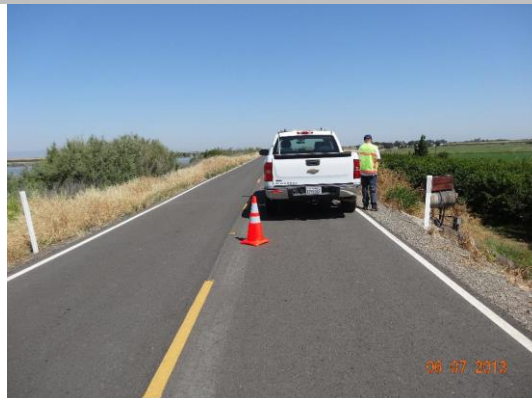
Photo 1 of 3 : UCIP\_FA\_2018\_44872\_33392.jpg

Comment Code					
Inspector Comment					
FS_ID:44872 DS_ID:21045 EP_NO: 4733 Repair Type: Non-Urgent Crossing Status: Found UCIP Comments: Dense vegetation limits the inspector's visibility to identify signs of pipe failure (leaks) through the waterward slope. Recommend removing vegetation along pipe alignment to conduct proper inspection of structure and appurtenances. FIELD_STRUCT_DESC: 18-inch steel irrigation siphon pipe through the levee, 4 feet below the crown. Cutoff wall around the pipe at the center of the levee. Siphon breaker on the apex of the pipe on the landside (LS) shoulder. Rock revetment on the waterside (WS) slope. 16-inch pipe welded to the 18-inch pipe near the LS shoulder and extends down the LS slope. Pipe exposed along both slopes. (Plans for installing a siphon pipe through the levee authorized under Permit No. 4733, 1964 - Kenneth R. Stewart). [Additional Reference(s): DWR Levee Log, 2005]. FS Date: 6/7/2013

View of levee crown at crossing.

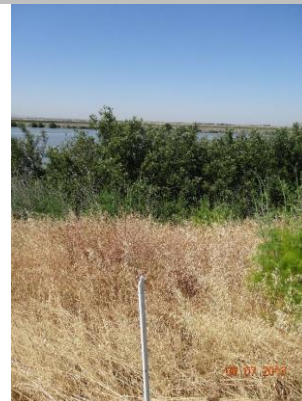
Photo 2 of 3 : UCIP\_FA\_2018\_44872\_33393.jpg

Dense vegetation hindered inspection on waterward side.

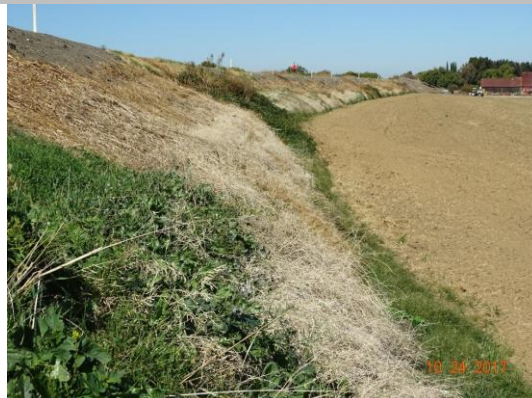
Photo 1 of 1 : FA\_2018\_RD0501\_170\_21\_20180925\_00002.jpg

LM Start	3.07	Rating **	M	Issue No.	21
LM End	3.33	Issue Type +	En	Location *	LS
Category	Earthen Levee			GPS Latitude/Longitude	
				Start	End
Item	Encroachments			38.221103°	38.224732°
				-121.671348°	-121.672668°
DWR ID	DWR_RD0501_02_f_2017_21				
Comment Code					
AT : Agricultural tilling					
Inspector Comment					
Aggricultural activity has cut into the landside levee toe resulting in a 4-foot tall, near vertical cut at the toe. This may destabilize the slope above. The toe should be reconstructed to the same slope angle as the levee slope above it.

Aggricultural activity has cut into the landside levee toe resulting in a 4-foot tall, near vertical cut at the toe. This may destabilize the slope above. The toe should be reconstructed to the same slope angle as the levee slope above it.

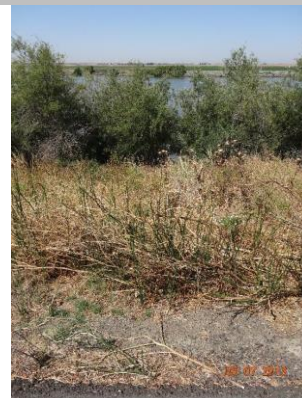
Photo 1 of 3 : UCIP\_FA\_2018\_19657\_33396.jpg

Comment Code						
Inspector Comment						
FS_ID:19657 DS_ID:21046 EP_NO: N/A Repair Type: Non-Urgent Crossing Status: Found UCIP Comments: Dense vegetation limits the inspector's visibility to identify signs of pipe failure (leaks) through the waterward slope. Recommend removing vegetation along pipe alignment to conduct proper inspection of structure and appurtenances. FIELD_STRUCT_DESC: 16-inch welded steel irrigation siphon pipe sleeved through a 20-inch coated steel pipe through the levee, 4.7 feet below the crown. Annular space grouted. Siphon breaker on the landside (LS) shoulder. Pipe exposed along both slopes. (Plans to place a new 16-inch welded steel pipe within the old 20-inch siphon authorized under Permit No. 2645, 1957 - Henry and Joseph Passaglia). [Additional Reference(s): DWR Levee Log, 2005. USACE Sacramento O&M Manual 105, April 1959, (HLM 3.3)]. FS Date: 8/22/2013

Dense vegetation along the crown hinge point and beginning section of waterward slope.

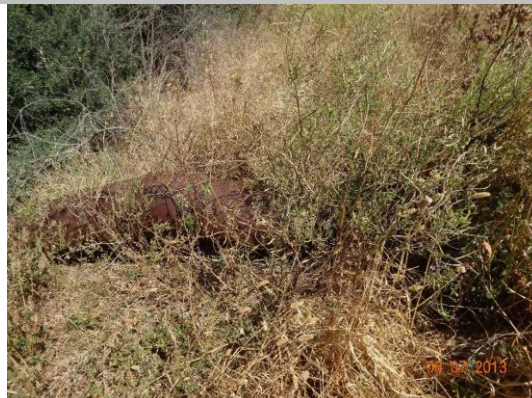
Photo 2 of 3 : UCIP\_FA\_2018\_19657\_33400.jpg

Comment Code						
Inspector Comment						
FS_ID:19657 DS_ID:21046 EP_NO: N/A Repair Type: Non-Urgent Crossing Status: Found UCIP Comments: Dense vegetation limits the inspector's visibility to identify signs of pipe failure (leaks) through the waterward slope. Recommend removing vegetation along pipe alignment to conduct proper inspection of structure and appurtenances. FIELD_STRUCT_DESC: 16-inch welded steel irrigation siphon pipe sleeved through a 20-inch coated steel pipe through the levee, 4.7 feet below the crown. Annular space grouted. Siphon breaker on the landside (LS) shoulder. Pipe exposed along both slopes. (Plans to place a new 16-inch welded steel pipe within the old 20-inch siphon authorized under Permit No. 2645, 1957 - Henry and Joseph Passaglia). [Additional Reference(s): DWR Levee Log, 2005. USACE Sacramento O&M Manual 105, April 1959, (HLM 3.3)]. FS Date: 8/22/2013

Dense vegetation along the upper portion of the waterward slope prevents proper inspection of crossing.

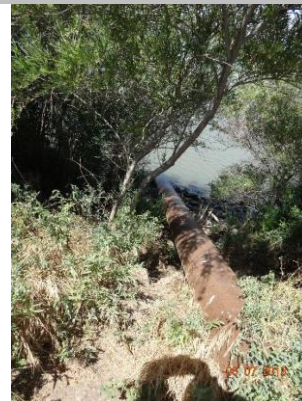
Photo 3 of 3 : UCIP\_FA\_2018\_19657\_33397.jpg

Overview of pipe along waterward side.

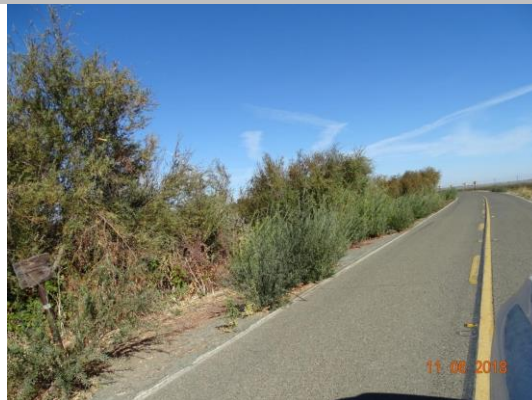
Photo 1 of 1 : FA\_2018\_RD0501\_171\_44\_20181106\_00078.jpg

LM Start	0.55	Rating **	M	Issue No.	44
LM End	0.60	Issue Type +	Ma	Location *	WS
Category	Earthen Levee			GPS Latitude/Longitude	
				Start	End
Item	Vegetation			38.233892 °	38.234412 °
				-121.666203 °	-121.665627 °
DWR ID	DWR_RD0501_03_f_2018_44				
Comment Code					
V2 : Remove the wild growth other than native grasses from the levee slopes.					
Inspector Comment

View looking upstream of new willow growth on the water side shoulder (November 2018).

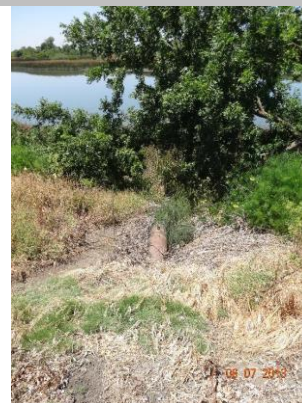
Photo 1 of 3 : UCIP\_FA\_2018\_44873\_33405.jpg

Comment Code						
Inspector Comment						
FS_ID:44873 DS_ID:21065 EP_NO: N/A Repair Type: Non-Urgent Crossing Status: Found UCIP Comments: Pump operating during inspection. Need to determine owner. Dense vegetation limits the inspector's visibility to identify signs of pipe failure (leaks) through the waterward slope. Recommend removing vegetation along pipe alignment to conduct proper inspection of structure and appurtenances. FIELD_STRUCT_DESC: 14-inch steel irrigation discharge pipe through the levee, 6.3 feet below the crown. Siphon breaker on the landside (LS) slope. Pipe exposed on both slopes. [Additional Reference(s): DWR Levee Log, 2005. USACE Sacramento O&M Manual 105, April 1959, (HLM 0.7), 16-inch pipe referenced]. FS Date: 6/7/2013

Overview of waterward side. Dense vegetation limits proper inspection.

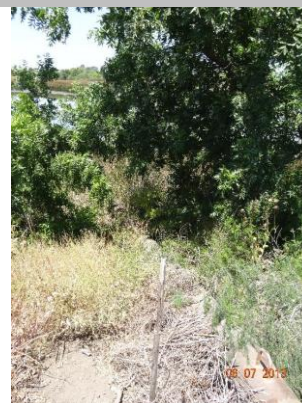
Photo 2 of 3 : UCIP\_FA\_2018\_44873\_33402.jpg

Conditions of waterward slope--dense vegetation along slope.

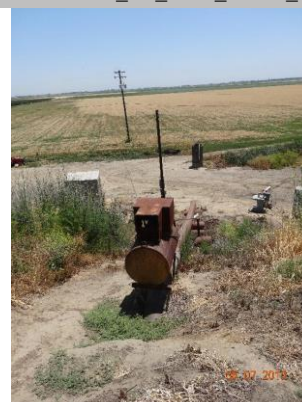
Photo 3 of 3 : UCIP\_FA\_2018\_44873\_33404.jpg

Overview of landward side--pump sytem, pipe, and standpipe.

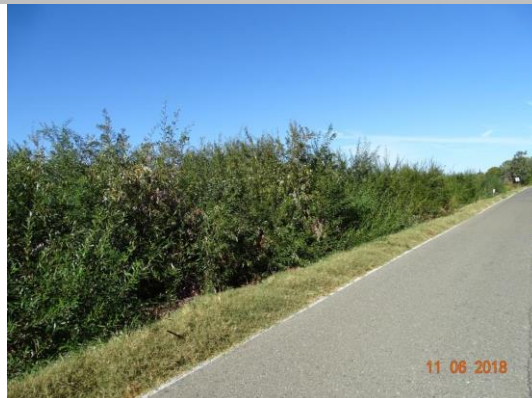
Photo 1 of 1 : FA\_2018\_RD0501\_171\_45\_20181106\_00081.jpg

LM Start	0.90	Rating **	M	Issue No.	45
LM End	0.97	Issue Type +	Ma	Location *	WS
Category	Earthen Levee			GPS Latitude/Longitude	
				Start	End
Item	Vegetation			38.238695 °	38.239740 °
				-121.664858 °	-121.664782 °
DWR ID	DWR_RD0501_03_f_2018_45				
Comment Code					
V2 : Remove the wild growth other than native grasses from the levee slopes.					
Inspector Comment

View looking upstream at thick vegetation on the water side slope (November 2018).

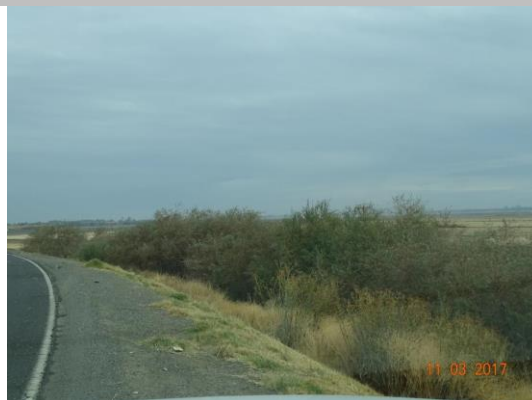
Photo 1 of 1 : FA\_2018\_RD0501\_171\_28\_20180925\_00001.jpg

LM Start	1.48	Rating **	M	Issue No.	28
LM End	1.48	Issue Type +	Ma	Location *	LS
Category	Earthen Levee			GPS Latitude/Longitude	
				Start	End
Item	Trim / Thin Trees			38.244293 °	38.244293 °
				-121.657843 °	-121.657843 °
DWR ID	DWR_RD0501_03_f_2017_28				
Comment Code					
T2 : Thin trees to allow visibility of the ground and room to flood fight.					
Inspector Comment					
Trim/thin willows to allow inspection and access to landside slope and toe.

Trim/thin willows to allow inspection and access to landside slope and toe.

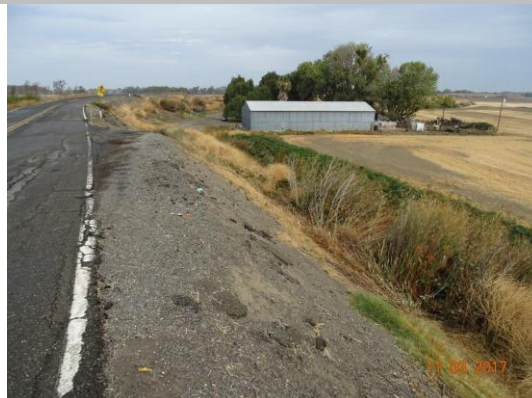
Photo 1 of 1 : FA\_2018\_RD0501\_171\_29\_20180925\_00002.jpg

LM Start	1.56	Rating **	M	Issue No.	29
LM End	1.56	Issue Type +	Ma	Location *	LS
Category	Earthen Levee			GPS Latitude/Longitude	
				Start	End
Item	Vegetation			38.245445 °	38.245445 °
				-121.658035 °	-121.658035 °
DWR ID	DWR_RD0501_03_f_2017_29				
Comment Code					
V2 : Remove the wild growth other than native grasses from the levee slopes.					
Inspector Comment					
Remove berry vines at landside toe to allow inspection and access.

Remove berry vines at landside toe to allow inspection and access.

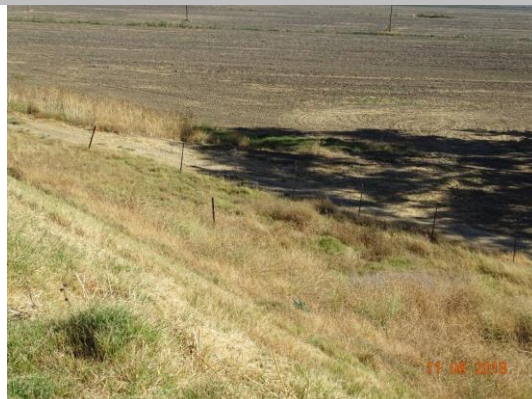
Photo 1 of 1 : FA\_2018\_RD0501\_171\_46\_20181106\_00079.jpg

LM Start	1.70	Rating **	M	Issue No.	46
LM End	1.70	Issue Type +	En	Location *	LS
Category	Earthen Levee			GPS Latitude/Longitude	
				Start	End
Item	Encroachments			38.247218 °	38.247218 °
				-121.658217 °	-121.658217 °
DWR ID	DWR_RD0501_03_f_2018_46				
Comment Code					
FE : Fence					
Inspector Comment					
Fence on land side toe does not have permit

View of unpermitted fence on the land side toe (November 2018).

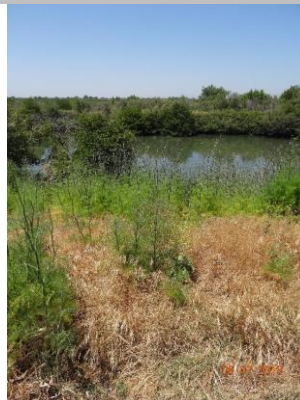
Photo 1 of 2 : UCIP\_FA\_2018\_43503\_33410.jpg

Comment Code						
Inspector Comment						
FS_ID:43503						
DS_ID:21068						
EP_NO: N/A						
Repair Type: Non-Urgent						
Crossing Status: Found						
UCIP Comments: Authorized or Unauthorized? Need permit authorizing work. Dense vegetation limits the inspector's visibility to identify signs of pipe failure (leaks) through the slope on both waterward and landward side. Recommend removing vegetation along pipe alignment to conduct proper inspection of structure and appurtenances.						
FIELD_STRUCT_DESC: 10-inch steel irrigation discharge pipe through the levee, 6.3 feet below the crown. Pump, gate valve, and switch box on the waterside (WS) slope. [Additional Reference(s): DWR Levee Log, 2005. USACE Sacramento O&M Manual 105, April 1959, (HLM 2.0), reported as 3.8 feet below the crown].						
FS Date: 6/7/2013

Overview of waterward side. Pipe is completely obstructed by dense vegetation.

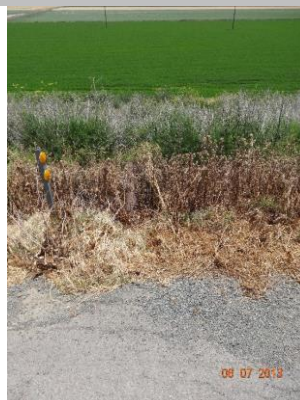
Photo 2 of 2 : UCIP\_FA\_2018\_43503\_33411.jpg

Overview of landward side. Pipe is visible however dense vegetation limits proper inspection.

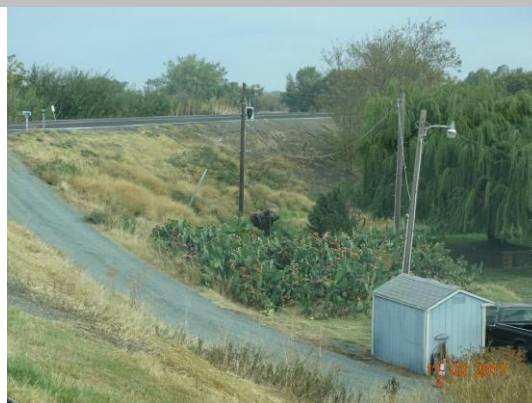
Photo 1 of 2 : FA\_2018\_RD0501\_171\_31\_20180925\_00004.jpg

LM Start	2.20	Rating **	M	Issue No.	31
LM End	2.20	Issue Type +	En	Location *	LS
Category	Earthen Levee			GPS Latitude/Longitude	
				Start	End
Item	Vegetation			38.253885 °	38.253885 °
				-121.655353 °	-121.655353 °
DWR ID	DWR_RD0501_03_f_2018_31				
Comment Code					
V6 : Landscaping					
Inspector Comment					
Remove large cactus at landside toe to allow inspection and access.

Remove large cactus at landside toe to allow inspection and access.

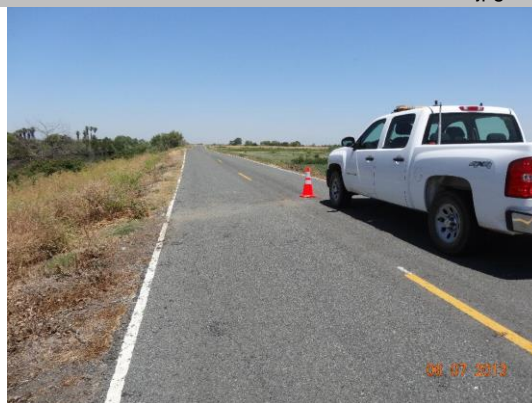
Photo 1 of 3 : UCIP\_FA\_2018\_18945\_31607.jpg

Comment Code						
Inspector Comment						
FS_ID:18945						
DS_ID:21047						
EP_NO: N/A						
Repair Type: Non-Urgent						
Crossing Status: Found						
UCIP Comments: Need to determine owner of structure. Recommend removing vegetation along pipe alignment to conduct proper inspection of structure and appurtenances.						
FIELD_STRUCT_DESC: 16-inch steel irrigation siphon pipe through the levee, 3.3 feet below the crown. Gate valve and switch box on the landside (LS) slope. Pipe exposed on both slopes. Riprap on the waterside (WS). [Additional Reference(s): DWR Levee Log, 2005. USACE Sacramento O&M Manual 105, April 1959, (HLM 2.7)].						
FS Date: 6/7/2013

Overview of levee crown at crossing.

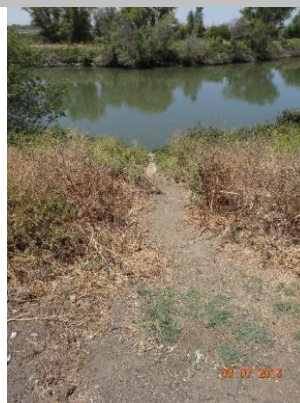
Photo 2 of 3 : UCIP\_FA\_2018\_18945\_31609.jpg

Overview of waterward side. Pipe is mostly buried through waterward side.

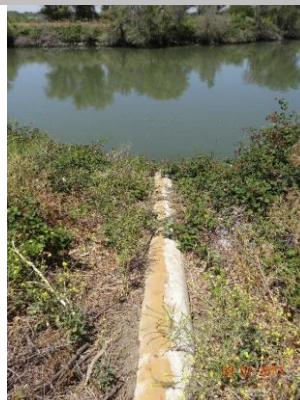
Photo 3 of 3 : UCIP\_FA\_2018\_18945\_31608.jpg

Exposed section of pipe located on waterward side.

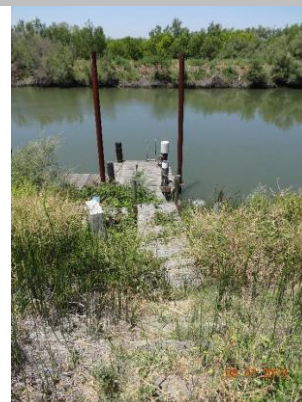
Photo 2 of 3 : UCIP\_FA\_2018\_32538\_58999.jpg

Comment Code						
Inspector Comment						
FS_ID:32538						
DS_ID:21048						
EP_NO: N/A						
Repair Type: Non-Urgent						
Crossing Status: Found						
UCIP Comments: Dense vegetation limits the inspector's visibility to identify signs of pipe failure (leaks) through the waterward slope.						
Recommend removing vegetation along pipe alignment to conduct proper inspection of structure and appurtenances. Need to find owner of crossing and determine if permit number is available.						
FIELD_STRUCT_DESC: 12-inch steel irrigation discharge pipe through the levee, 5 feet below the crown. Pump on a pile structure in the stream. Service pole on the landside (LS) slope. Concrete standpipe at the LS toe. [Additional Reference(s): DWR Levee Log, 2005. USACE Sacramento O&M Manual 105, April 1959, (HLM 3.8)].						
FS Date: 6/7/2013

View of waterward side. Dense vegetation throughout waterward side. Walkway visible and support piles.

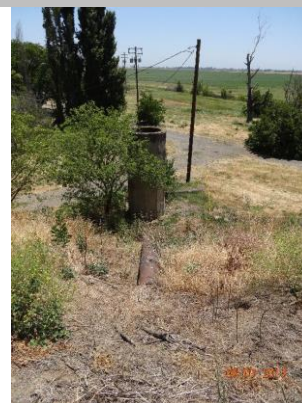
Photo 3 of 3 : UCIP\_FA\_2018\_32538\_58998.jpg

View of landward side--section of pipe exposed and Standpipe.

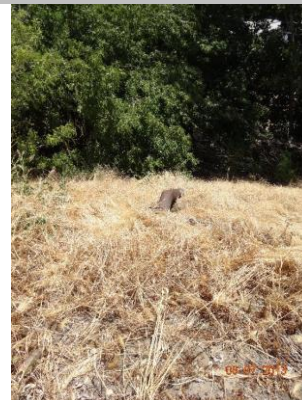
Photo 1 of 3 : UCIP\_FA\_2018\_46768\_30382.jpg

Comment Code					
Inspector Comment					
FS_ID:46768 DS_ID:21049 EP_NO: 1557 Repair Type: Non-Urgent Crossing Status: Found UCIP Comments: Crossing appears abandoned--wooden platform structure appears to be abandoned on waterward side. Small hole underneath pipe on landward side--unable to determine cause (rodent/pipe leak) Need to find owner of crossing to determine status. Recommend removing vegetation along pipe alignment to conduct proper inspection of structure and appurtances. FIELD_STRUCT_DESC: *ABANDONED* 6-inch irrigation discharge pipe of an unknown material through the levee, 2.5 feet below the crown. Pump in a pump house on the waterside (WS) slope. (Plans for the construction of two irrigation pumping plants, about 500 feet apart, and 6-inch discharge pipes through the levee authorized under Permit No. 1557, 1951 - Poultry Producers of Central California). [Additional Reference(s): DWR Levee Log, 2005. USACE Sacramento O&M Manual 105, April 1959, (HLM 3.9)]. FS Date: 6/7/2013

View of landward side showing a small section of pipe exposed.

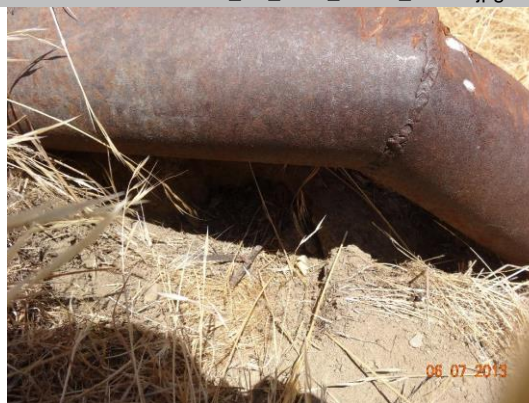
Photo 2 of 3 : UCIP\_FA\_2018\_46768\_30381.jpg

Burrow activity visible underneath pipe alignment.

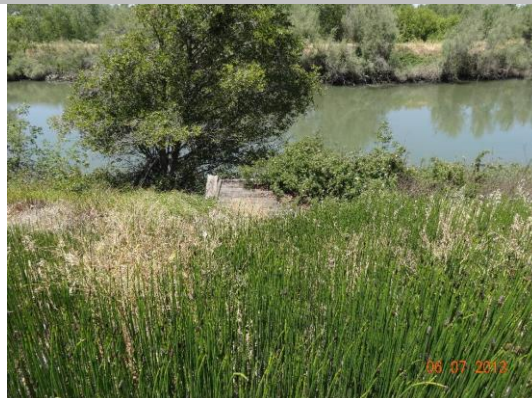
Photo 3 of 3 : UCIP\_FA\_2018\_46768\_30380.jpg

Overview of waterward side with limited access to structure.

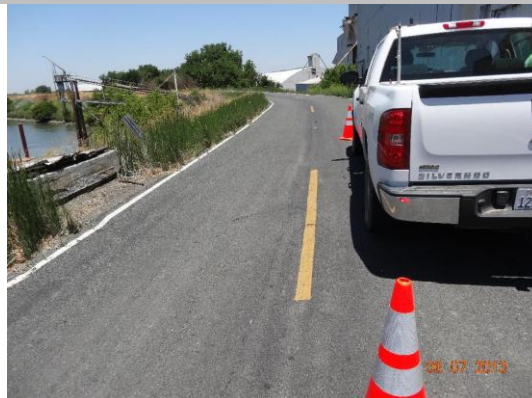
Photo 1 of 3 : UCIP\_FA\_2018\_32540\_59007.jpg

Comment Code						
Inspector Comment						
FS_ID:32540 DS_ID:21050 EP_NO: N/A Repair Type: Non-Urgent Crossing Status: Found UCIP Comments: Unable to properly inspect structure--limited access. Also unable to determine if structure is still in use. Levee logs indicate this crossing is abandoned. If structre is no longer used-how to prevent water from flowing through levee during flood season. If structure no longer in use owner will need to coordinate with CVFPB. FIELD_STRUCT_DESC: *ABANDONED* 66-inch by 66-inch reinforced concrete gravity drainage tunnel through the levee, 6.5 feet below the crown. [Additional Reference(s): DWR Levee Log, 2005]. FS Date: 6/7/2013

View of narrow levee crown.

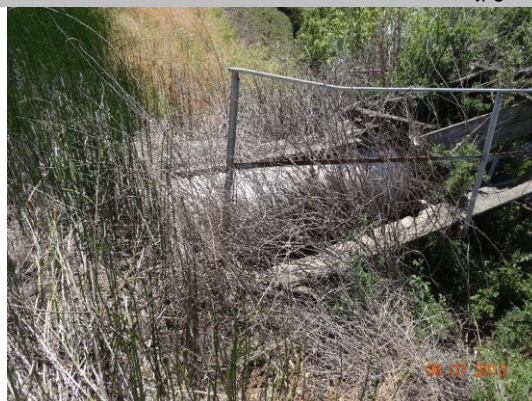
Photo 1 of 3 : UCIP\_FA\_2018\_19662\_33420.jpg

Comment Code					
Inspector Comment					
FS_ID:19662 DS_ID:21052 EP_NO: N/A Repair Type: Non-Urgent Crossing Status: Found UCIP Comments: Need to abandon structure properly--contact owner. Also if crossing is still in use--recommend removing vegetation along pipe alignment to conduct proper inspection of structure and appurtenances. FIELD_STRUCT_DESC: 36-inch grain conveyor culvert of an unknown material through the levee, 5 feet below the crown. Grain loading auger sleeved through the culvert. Grain loading system on a platform in the channel. (Plans for installing a 36-inch culvert to be used for housing a 14-inch screw-type bulk grain conveyor through the levee authorized under Permit No. 1503, 1959 - Bay Cities Transportation Company). [Additional Reference(s): DWR Levee Log, 2005. USACE Sacramento O&M Manual 105, April 1950, (HLM 4.0)]. FS Date: 6/7/2013

View of waterward side. Pipe visible through dense vegetation.

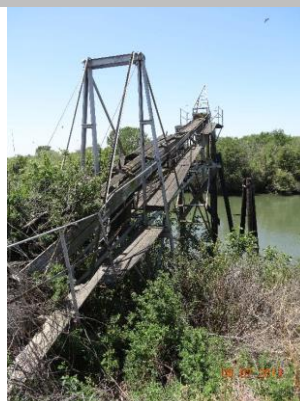
Photo 3 of 3 : UCIP\_FA\_2018\_19662\_33419.jpg

Reminiscence of grain loading auger located on waterward slope.

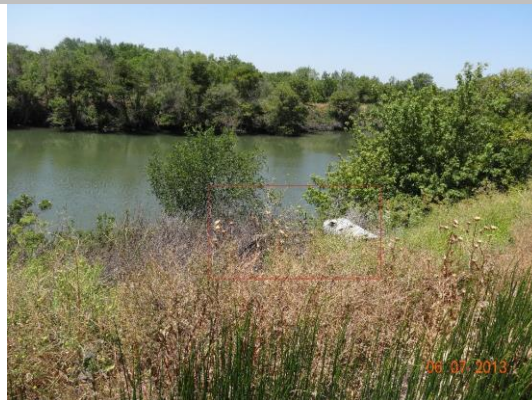
Photo 1 of 3 : UCIP\_FA\_2018\_43524\_33425.jpg

Comment Code						
Inspector Comment						
FS_ID:43524 DS_ID:21053 EP_NO: N/A Repair Type: Non-Urgent Crossing Status: Found UCIP Comments: Dense vegetation limits the inspector's visibility to identify signs of pipe failure (leaks) through the waterward slope. Recommend removing vegetation along pipe alignment to conduct proper inspection of structure and appurtenances. FIELD_STRUCT_DESC: 6-inch irrigation discharge pipe of an unknown material through the levee, 2.5 feet below the crown. Pump in a pump house on the waterside (WS) slope. (Plans for the construction of two irrigation pumping plants, about 500 feet apart, and 6-inch discharge pipes through the levee authorized under Permit No. 1557, 1951 - Poultry Producers of Central California). [Additional Reference(s): DWR Levee Log, 2005. USACE Sacramento O&M Manual 105, April 1959, (HLM 4.0)]. FS Date: 6/7/2013

View of waterward side. Dense vegetation limits inspections. Signs of structure visible highlighted by red box.

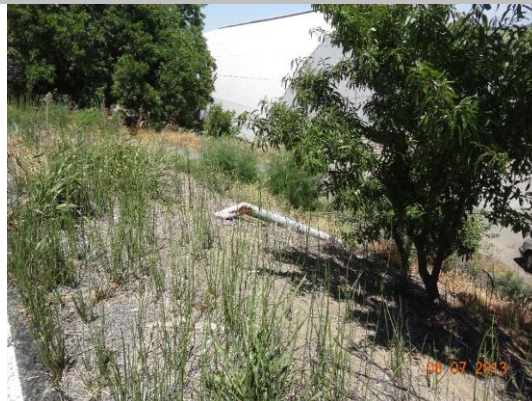
Photo 2 of 3 : UCIP\_FA\_2018\_43524\_33424.jpg

View of landward side. Pipe visible.

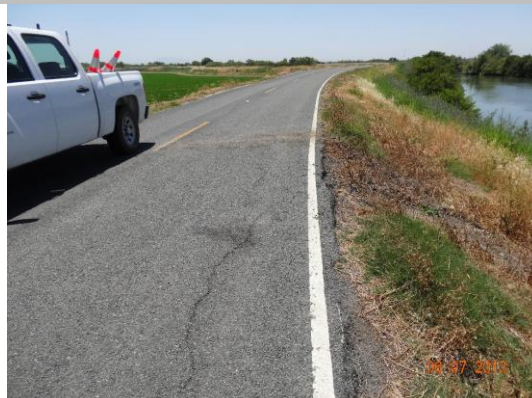
Photo 1 of 3 : UCIP\_FA\_2018\_44876\_33427.jpg

Comment Code					
Inspector Comment					
FS_ID:44876 DS_ID:21069 EP_NO: N/A Repair Type: Non-Urgent Crossing Status: Found UCIP Comments: Damage to levee shoulder. Crossing appears to be still be in use--need to contact owner to inform about maintenance issues. Dense vegetation limits the inspector's visibility to identify signs of pipe failure (leaks) along the waterward and landward slope. Recommend removing vegetation along pipe alignment to conduct proper inspection of structure and appurtenances. FIELD_STRUCT_DESC: 18-inch steel irrigation discharge pipe sleeved through a 24-inch pipe of an unknown material through the levee, 6.5 feet below the crown. Cutoff wall around the pipe at the waterside (WS) shoulder. Siphon breaker on the apex of the pipe at the landside (LS) shoulder. Pump in a pump house on the LS slope. (Plans for an 18-inch steel pipe to be sleeved through the 24-inch pipe with annular space grouted authorized under Permit No. 2496, 1957 - Reclamation District No. 501 [RD0501]). [Additional Reference(s): DWR Levee Log, 2005. USACE Sacramento O&M Manual 105, April 1959, (HLM 4.6)]. FS Date: 6/7/2013

Line cracks along crown near crown hinge point on waterward side.

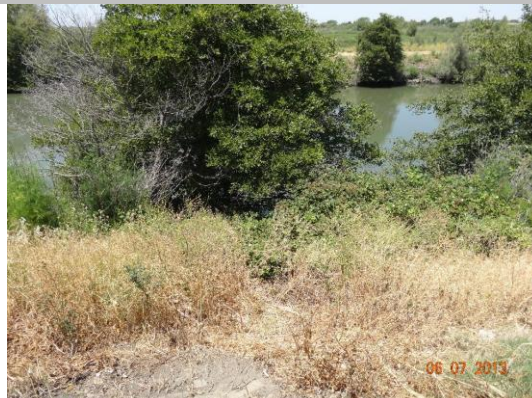
Photo 2 of 3 : UCIP\_FA\_2018\_44876\_33428.jpg

View of waterward slope. Dense vegetation along slope.

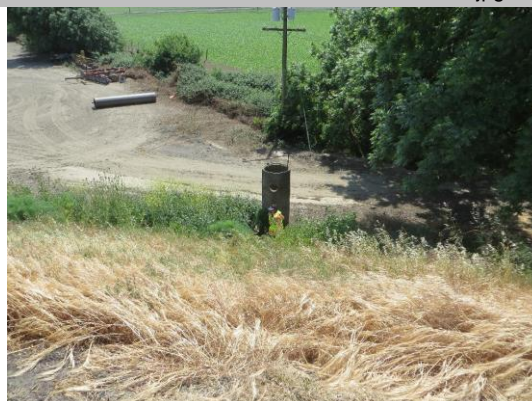
Photo 1 of 2 : UCIP\_FA\_2018\_44746\_73944.jpg

LM Start	4.31	Rating **	M	Issue No.	62
LM End	4.31	Issue Type +	En	Location *	
Category	Supplemental			GPS Latitude/Longitude	
				Start	End
Item	DWR UCIP Field Study			38.275955°	38.275955°
				-121.638626°	-121.638626°
DWR ID	21107				
Comment Code					
Inspector Comment					
FS_ID:44746 DS_ID:21107 EP_NO: N/A Repair Type: Non-Urgent Crossing Status: Indicator Found UCIP Comments: Need to verify type of abandonment. FIELD_STRUCT_DESC: *ABANDONED* 10-inch irrigation discharge pipe of an unknown material through the levee, 4.8 feet below the crown. 34-inch concrete standpipe on the landside (LS) toe. 10-inch hole in the standpipe where the abandoned pipe once connected. [Additional Reference(s): USACE Sacramento O&M Manual 105, April 1959, (HLM 4.6)]. FS Date: 4/23/2015

34-inch diameter concrete standpipe at LS toe.

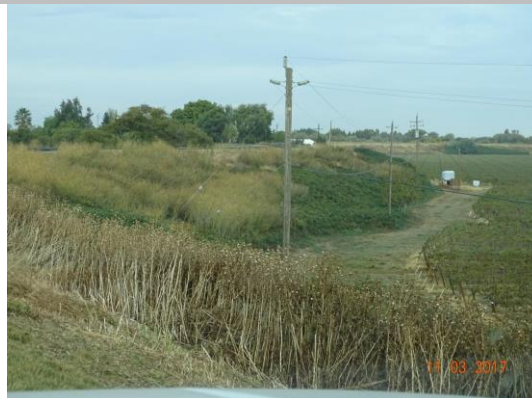
Photo 1 of 1 : FA\_2018\_RD0501\_171\_34\_20180925\_00006.jpg

LM Start	4.47	Rating **	M	Issue No.	34
LM End	4.80	Issue Type +	Ma	Location *	LS
Category	Earthen Levee			GPS Latitude/Longitude	
				Start	End
Item	Vegetation			38.277918 °	38.281507 °
				-121.637670 °	-121.641595 °
DWR ID	DWR_RD0501_03_f_2017_34				
Comment Code					
V2 : Remove the wild growth other than native grasses from the levee slopes.					
Inspector Comment					
Remove berry vines on landside slope and toe to allow inspection and access.

Remove berry vines on landside slope and toe to allow inspection and access.

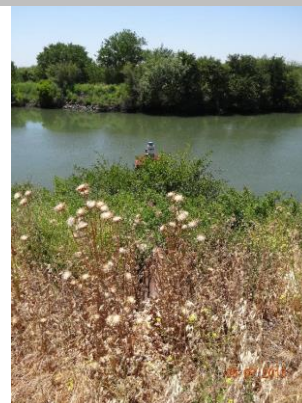
Photo 1 of 2 : UCIP\_FA\_2018\_32541\_59008.jpg

Comment Code					
Inspector Comment					
FS_ID:32541 DS_ID:21071 EP_NO: N/A Repair Type: Non-Urgent Crossing Status: Found UCIP Comments: --Contact owner--Dense vegetation limits the inspector's visibility to identify signs of pipe failure (leaks) along the waterward and landward slopes. Recommend removing vegetation along pipe alignment to conduct proper inspection of structure and appurtances. Walkway and siphon breaker not found. FIELD_STRUCT_DESC: 12-inch reinforced concrete irrigation discharge pipe through the levee, 2.5 feet below the crown. Cutoff wall around the pipe at the center of the levee. Siphon breaker at the apex of the pipe on the shoulder. Pump on a pile structure in the stream. Walkway access to pump. [Additional Reference(s): DWR Levee Log, 2005. USACE Sacramento O&M Manual 105, April 1959, (HLM 5.1)]. FS Date: 6/7/2013

View of waterward side. Pump located on pile structure in stream.

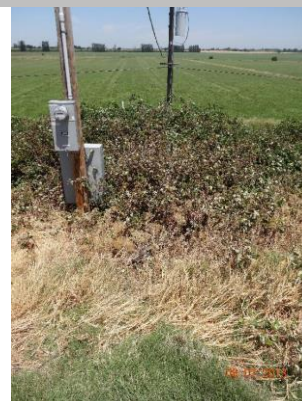
Photo 2 of 2 : UCIP\_FA\_2018\_32541\_59009.jpg

Comment Code						
Inspector Comment						
FS_ID:32541						
DS_ID:21071						
EP_NO: N/A						
Repair Type: Non-Urgent						
Crossing Status: Found						
UCIP Comments: --Contact owner--Dense vegetation limits the inspector's visibility to identify signs of pipe failure (leaks) along the waterward and landward slopes. Recommend removing vegetation along pipe alignment to conduct proper inspection of structure and appurtances. Walkway and siphon breaker not found.						
FIELD_STRUCT_DESC: 12-inch reinforced concrete irrigation discharge pipe through the levee, 2.5 feet below the crown. Cutoff wall around the pipe at the center of the levee. Siphon breaker at the apex of the pipe on the shoulder. Pump on a pile structure in the stream. Walkway access to pump. [Additional Reference(s): DWR Levee Log, 2005. USACE Sacramento O&M Manual 105, April 1959, (HLM 5.1)].						
FS Date: 6/7/2013

View of landward side. Power source and control box on landward side.

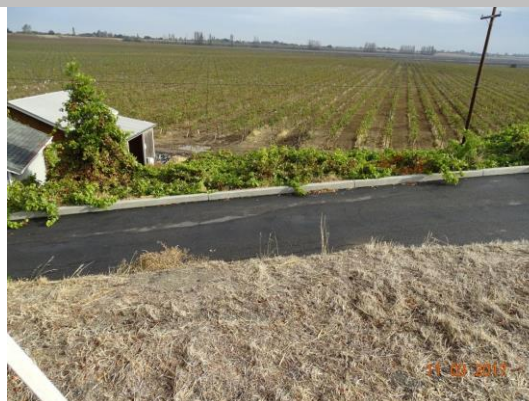
Photo 1 of 1 : FA\_2018\_RD0501\_171\_35\_20180925\_00007.jpg

LM Start	4.81	Rating **	M	Issue No.	35
LM End	4.81	Issue Type +	En	Location *	LS
Category	Earthen Levee			GPS Latitude/Longitude	
				Start	End
Item	Vegetation			38.281533 °	38.281533 °
				-121.641702 °	-121.641702 °
DWR ID	DWR_RD0501_03_f_2017_35				
Comment Code					
V6 : Landscaping					
Inspector Comment					
Remove, thin, trim landside landscaping (grape vines, bushes, trees) to allow inspection and access.

Remove, thin, trim landside landscaping (grape vines, bushes, trees) to allow inspection and access.

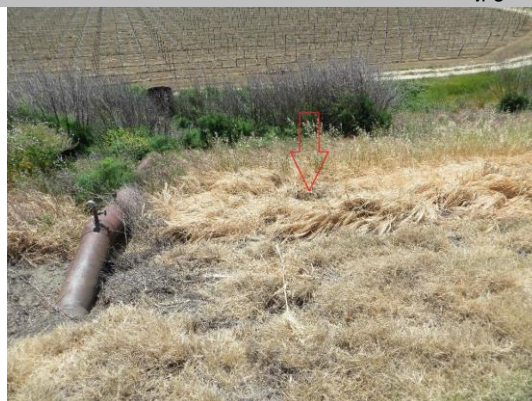
Photo 1 of 2 : UCIP\_FA\_2018\_44877\_73946.jpg

LM Start	5.43	Rating **	M	Issue No.	64	
LM End	5.43	Issue Type +	En	Location *		
Category	Supplemental			GPS Latitude/Longitude		
				Start	End	
Item	DWR UCIP Field Study			38.288951 °	38.288951 °	
				-121.644223 °	-121.644223 °	
DWR ID	21055					
Comment Code						
Inspector Comment						
FS_ID:44877						
DS_ID:21055						
EP_NO: N/A						
Repair Type: Non-Urgent						
Crossing Status: Found						
UCIP Comments: Pipe abandoned and should be done so properly.						
FIELD_STRUCT_DESC: 10-inch steel irrigation discharge pipe through the levee, 1.8 feet below the crown. Pump on a pile structure in the stream. Pipe exposed on the landside (LS). [Additional Reference(s): DWR Levee Log, 2005. USACE Sacramento O&M Manual 105, April 1959, (HLM 5.9)].						
FS Date: 4/23/2015

Buried pipe exposed in trench 8-feet downstream from visible pipe.

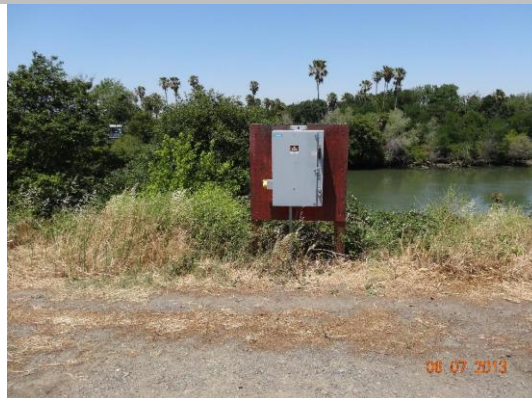
Photo 1 of 3 : UCIP\_FA\_2018\_19666\_33435.jpg

Comment Code						
Inspector Comment						
FS_ID:19666						
DS_ID:21054						
EP_NO: N/A						
Repair Type: Non-Urgent						
Crossing Status: Found						
UCIP Comments: Need to find owner and permit number authorizing work. Dense vegetation limits the inspector's visibility to identify signs of pipe failure (leaks) along the waterward and landward slopes.						
Recommend removing vegetation along pipe alignment to conduct proper inspection of structure and appurtenances.						
FIELD_STRUCT_DESC: 12-inch irrigation discharge pipe of an unknown material through the levee, 3 feet below the crown. Pump on a pile structure in the stream. [Additional Reference(s): DWR Levee Log, 2005].						
FS Date: 6/7/2013

Overview of waterward side. Control box located near levee crown.

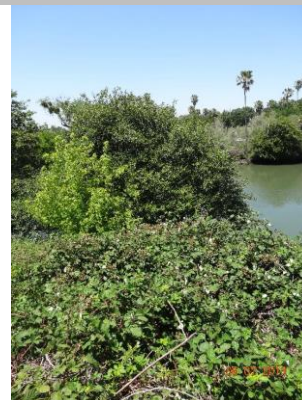
Photo 2 of 3 : UCIP\_FA\_2018\_19666\_33434.jpg

Structure visible through the dense vegetation. Limited access unable to inspect.

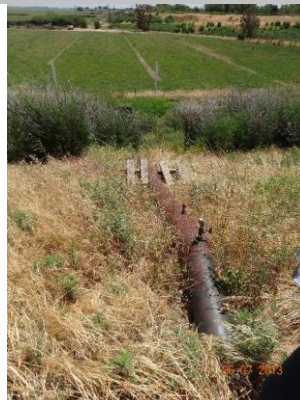
Photo 3 of 3 : UCIP\_FA\_2018\_19666\_33433.jpg

Comment Code						
Inspector Comment						
FS_ID:19666 DS_ID:21054 EP_NO: N/A Repair Type: Non-Urgent Crossing Status: Found UCIP Comments: Need to find owner and permit number authorizing work. Dense vegetation limits the inspector's visibility to identify signs of pipe failure (leaks) along the waterward and landward slopes. Recommend removing vegetation along pipe alignment to conduct proper inspection of structure and appurtenances. FIELD_STRUCT_DESC: 12-inch irrigation discharge pipe of an unknown material through the levee, 3 feet below the crown. Pump on a pile structure in the stream. [Additional Reference(s): DWR Levee Log, 2005]. FS Date: 6/7/2013

View of pipe on landward side. Dry vegetation covers landward slope.

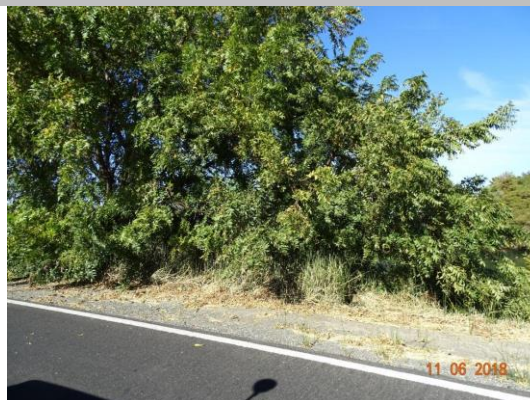
Photo 1 of 1 : FA\_2018\_RD0501\_171\_49\_20181106\_00080.jpg

LM Start	5.61	Rating **	M	Issue No.	49
LM End	5.61	Issue Type +	Ma	Location *	WS
Category	Earthen Levee			GPS Latitude/Longitude	
				Start	End
Item	Trim / Thin Trees			38.289848 °	38.289848 °
				-121.641113 °	-121.641113 °
DWR ID	DWR_RD0501_03_f_2018_49				
Comment Code					
T2 : Thin trees to allow visibility of the ground and room to flood fight.					
Inspector Comment

View of thick tree growth on the water side slope (November 2018).

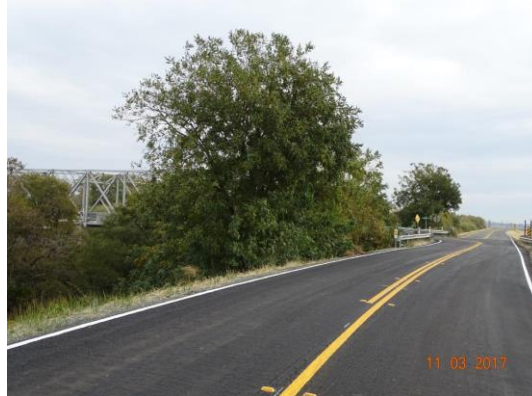
Photo 1 of 1 : FA\_2018\_RD0501\_171\_40\_20180925\_00009.jpg

LM Start	6.14	Rating **	M	Issue No.	40
LM End	6.14	Issue Type +	Ma	Location *	WS
Category	Earthen Levee			GPS Latitude/Longitude	
				Start	End
Item	Trim / Thin Trees			38.291563 °	38.291563 °
				-121.632068 °	-121.632068 °
DWR ID	DWR_RD0501_03_f_2017_40				
Comment Code					
T1 : Trim trees to at least five feet above ground level.					
Inspector Comment

Trim/thin trees on waterside to allow inspection and access.

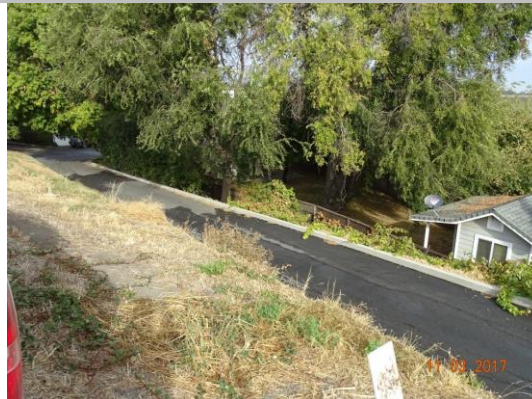
Photo 1 of 1 : FA\_2018\_RD0501\_171\_41\_20180925\_00010.jpg

LM Start	6.17	Rating **	M	Issue No.	41
LM End	6.17	Issue Type +	En	Location *	WS
Category	Earthen Levee			GPS Latitude/Longitude	
				Start	End
Item	Vegetation			38.291460 °	38.291460 °
				-121.631455 °	-121.631455 °
DWR ID	DWR_RD0501_03_f_2017_41				
Comment Code					
V6 : Landscaping					
Inspector Comment					
Trim/thin trees and landscaping to allow inspection and access to levee slope and toe.

Trim/thin trees and landscaping to allow inspection and access to levee slope and toe.

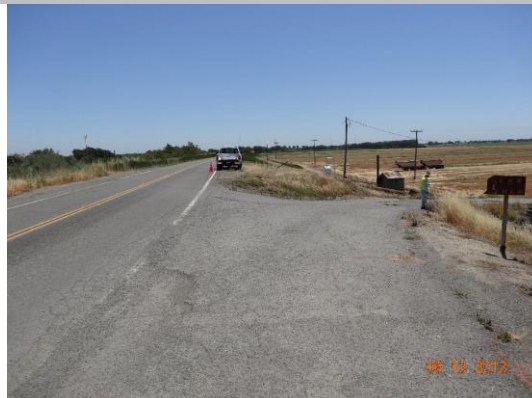
Photo 1 of 3 : UCIP\_FA\_2018\_32542\_59022.jpg

Comment Code					
Inspector Comment					
FS_ID:32542 DS_ID:21059 EP_NO: N/A Repair Type: Non-Urgent Crossing Status: Found UCIP Comments: Need to determine status of crossing. Horizontal and vertical cracks present on stand pipe located on landward side. Dense vegetation limits the inspector's visibility to identify signs of pipe failure (leaks) along the waterward slope. Recommend removing vegetation along pipe alignment to conduct proper inspection of structure and appurtenances. FIELD_STRUCT_DESC: 12-inch steel irrigation discharge pipe through the levee, 6 feet below the crown. 2-inch electrical conduit of an unknown material through the levee, at an unknown depth. Pump and gate valve on the waterside (WS) slope. Pipe exposed on the landside (LS). [Additional Reference(s): DWR Levee Log, 2005. USACE Sacramento O&M Manual 105, April 1959, (HLM 6.9)]. FS Date: 6/13/2013

Overview of levee crown at crossing.

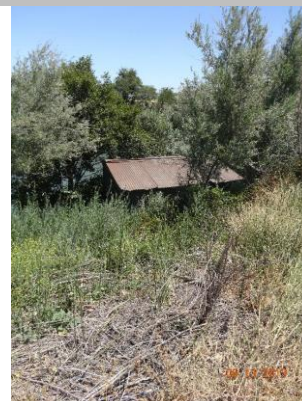
Photo 2 of 3 : UCIP\_FA\_2018\_32542\_59023.jpg

View of waterward side. Dense vegetation along levee slope.

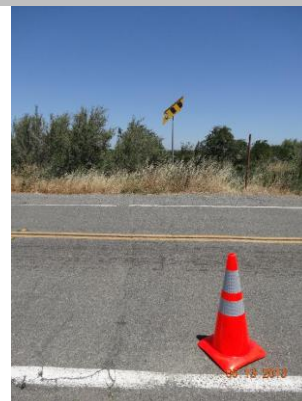
Photo 1 of 3 : UCIP\_FA\_2018\_42118\_72902.jpg

LM Start	6.40	Rating **	M	Issue No.	67	
LM End	6.40	Issue Type +	En	Location *		
Category	Supplemental			GPS Latitude/Longitude		
				Start	End	
Item	DWR UCIP Field Study			38.290356 °	38.290356 °	
				-121.627488 °	-121.627488 °	
DWR ID	24054					
Comment Code						
Inspector Comment						
FS_ID:42118						
DS_ID:24054						
EP_NO: N/A						
Repair Type: Non-Urgent						
Crossing Status: Indicator Found						
UCIP Comments: Need to determine encroachment number issued for pipe installation.						
FIELD_STRUCT_DESC: Natural gas pipeline of an unknown size or material through the levee at an angle, at an unknown depth. Markers visible on each side. [Additional Reference(s): DWR Levee Log, 2005. USACE Sacramento O&M Manual 105, April 1959, (HLM 6.9)].						
FS Date: 6/13/2013

Markers visible on waterward side.

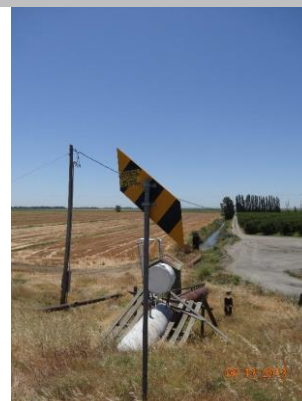
Photo 2 of 3 : UCIP\_FA\_2018\_42118\_72901.jpg

Marker visible on landward side.

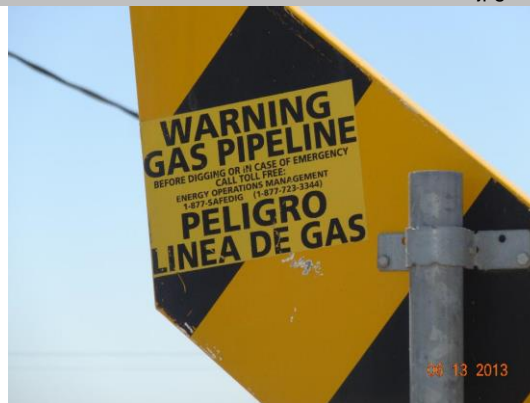
Photo 3 of 3 : UCIP\_FA\_2018\_42118\_72900.jpg

Marker with contact information on landward side.

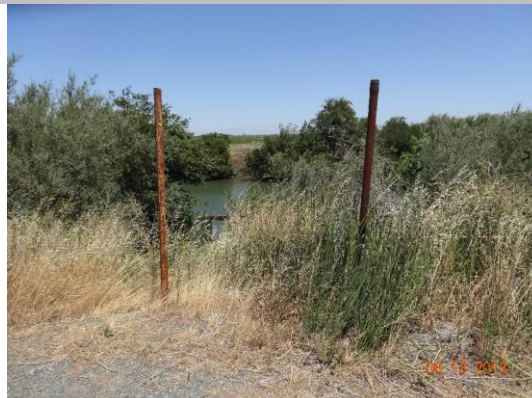
Photo 2 of 3 : UCIP\_FA\_2018\_19668\_33443.jpg

Comment Code					
Inspector Comment					
FS_ID:19668 DS_ID:21057 EP_NO: N/A Repair Type: Non-Urgent Crossing Status: Found UCIP Comments: Crossing was operating during inspection; Dense vegetation limits the inspector's visibility to identify signs of pipe failure (leaks) along the waterward slope. Recommend removing vegetation along pipe alignment to conduct proper inspection of structure and appurtenances. FIELD_STRUCT_DESC: 1 of 2: 30-inch coated steel irrigation siphon pipe through the levee, 9.5 feet below the crown. Cutoff wall around the pipe at the center of the levee. Siphon breaker on the landside (LS) slope. Primer tanks on the LS slope. Pipe exposed on both slopes. (Plans for the installation of a 30-inch siphon pipe through the levee authorized under Permit No. 611, 1934 - Reclamation District No. 501 [RD0501]. Plans to replace a 30-inch siphon pipe through the levee authorized under Permit No. 2497, 1957 - RD0501). [Additional Reference(s): DWR Levee Log, 2005. USACE Sacramento O&M Manual 105, April 1959, (HLM 6.9)]. FS Date: 6/13/2013

View of waterward side. Metal posts near the levee crown.

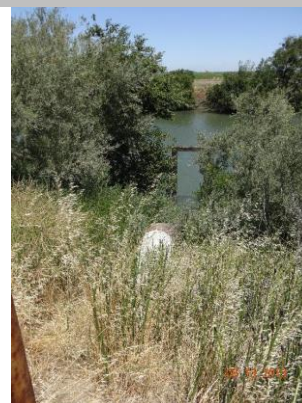
Photo 3 of 3 : UCIP\_FA\_2018\_19668\_33442.jpg

Comment Code						
Inspector Comment						
FS_ID:19668 DS_ID:21057 EP_NO: N/A Repair Type: Non-Urgent Crossing Status: Found UCIP Comments: Crossing was operating during inspection; Dense vegetation limits the inspector's visibility to identify signs of pipe failure (leaks) along the waterward slope. Recommend removing vegetation along pipe alignment to conduct proper inspection of structure and appurtenances. FIELD_STRUCT_DESC: 1 of 2: 30-inch coated steel irrigation siphon pipe through the levee, 9.5 feet below the crown. Cutoff wall around the pipe at the center of the levee. Siphon breaker on the landside (LS) slope. Primer tanks on the LS slope. Pipe exposed on both slopes. (Plans for the installation of a 30-inch siphon pipe through the levee authorized under Permit No. 611, 1934 - Reclamation District No. 501 [RD0501]. Plans to replace a 30-inch siphon pipe through the levee authorized under Permit No. 2497, 1957 - RD0501). [Additional Reference(s): DWR Levee Log, 2005. USACE Sacramento O&M Manual 105, April 1959, (HLM 6.9)]. FS Date: 6/13/2013

Pipe visible through dense vegetation. Reminiscence of platform located on river.

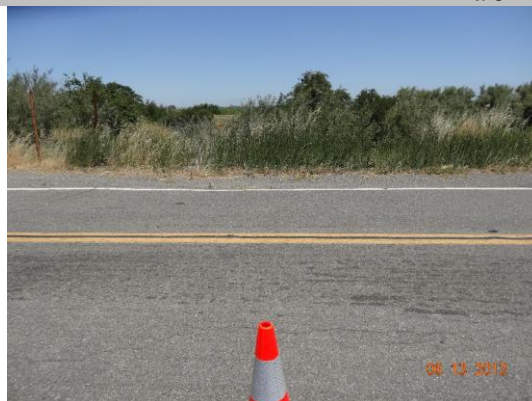
Photo 2 of 3 : UCIP\_FA\_2018\_32543\_59027.jpg

Comment Code						
Inspector Comment						
FS_ID:32543 DS_ID:21058 EP_NO: N/A Repair Type: Non-Urgent Crossing Status: Found UCIP Comments: Dense vegetation limits the inspector's visibility to identify signs of pipe failure (leaks) along the waterward slope. Recommend removing vegetation along pipe alignment to conduct proper inspection of structure and appurtenances. Need to find pipe owner. Unable to determine status of crossing. FIELD_STRUCT_DESC: *ABANDONED* 8-inch coated steel irrigation discharge pipe through the levee, 2.7 feet below the crown. Siphon breaker at the apex of the pipe on the landside (LS) shoulder. Surge chamber at the LS toe. Pump near the waterside (WS) toe. Pipe exposed on the LS. 4-foot by 3-foot concrete platform on the LS toe. 3-inch electrical conduit of an unknown material runs along the 8-inch coated steel pipe. [Additional Reference(s): DWR Levee Log, 2005. USACE Sacramento O&M Manual 105, April 1959, (HLM 6.9)]. FS Date: 6/13/2013

View levee crown at crossing.

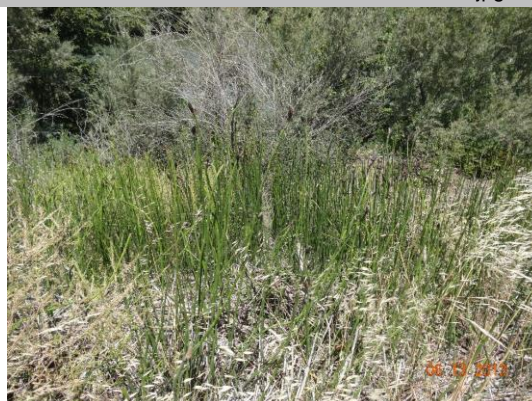
Photo 3 of 3 : UCIP\_FA\_2018\_32543\_59026.jpg

Comment Code						
Inspector Comment						
FS_ID:32543 DS_ID:21058 EP_NO: N/A Repair Type: Non-Urgent Crossing Status: Found UCIP Comments: Dense vegetation limits the inspector's visibility to identify signs of pipe failure (leaks) along the waterward slope. Recommend removing vegetation along pipe alignment to conduct proper inspection of structure and appurtenances. Need to find pipe owner. Unable to determine status of crossing. FIELD_STRUCT_DESC: *ABANDONED* 8-inch coated steel irrigation discharge pipe through the levee, 2.7 feet below the crown. Siphon breaker at the apex of the pipe on the landside (LS) shoulder. Surge chamber at the LS toe. Pump near the waterside (WS) toe. Pipe exposed on the LS. 4-foot by 3-foot concrete platform on the LS toe. 3-inch electrical conduit of an unknown material runs along the 8-inch coated steel pipe. [Additional Reference(s): DWR Levee Log, 2005. USACE Sacramento O&M Manual 105, April 1959, (HLM 6.9)]. FS Date: 6/13/2013

View of waterward side. Dense vegetation along levee slope.

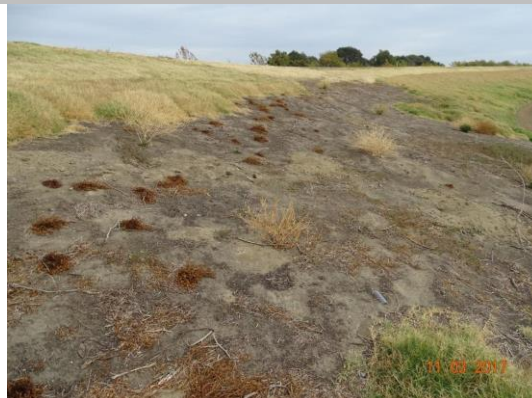
Photo 1 of 1 : FA\_2018\_RD0501\_171\_39\_20180925\_00008.jpg

LM Start	6.61	Rating **	M	Issue No.	39
LM End	6.61	Issue Type +	Ma	Location *	LS
Category	Earthen Levee			GPS Latitude/Longitude	
				Start	End
Item	Animal Control			38.290313 °	38.290313 °
				-121.623785 °	-121.623785 °
DWR ID	DWR_RD0501_03_f_2016_39				
Comment Code					
A1 : Exterminate rodents and backfill and compact or grout burrows.					
Inspector Comment					
Evidence of significant rodent activity at this location. Exterminate the rodents and backfill holes.

Evidence of significant rodent activity at this location. Exterminate the rodents and backfill holes.

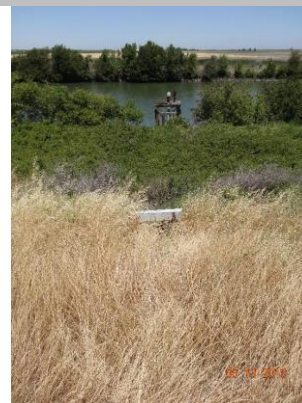
Photo 1 of 3 : UCIP\_FA\_2018\_32544\_59034.jpg

Comment Code					
Inspector Comment					
FS_ID:32544					
DS_ID:21060					
EP_NO: N/A					
Repair Type: Non-Urgent					
Crossing Status: Found					
UCIP Comments: Dense vegetation limits the inspector's visibility to identify signs of pipe failure (leaks) along the slope. Recommend removing vegetation along pipe alignment to conduct proper inspection of structure and appurtenances. Walkway missing but platform remain on the waterward side.					
FIELD_STRUCT_DESC: 12-inch irrigation discharge pipe of an unknown material through the levee, 6.5 feet below the crown. Switch panel on the waterside (WS) slope. Pump on a pile structure in the stream. [Additional Reference(s): DWR Levee Log, 2005. USACE Sacramento O&M Manual 105, April 1959, (HLM 7.3)].					
FS Date: 6/13/2013

View of waterward side. Support piles, conduit line, and pump visible on waterward side. Dense vegetation covers waterward slope.

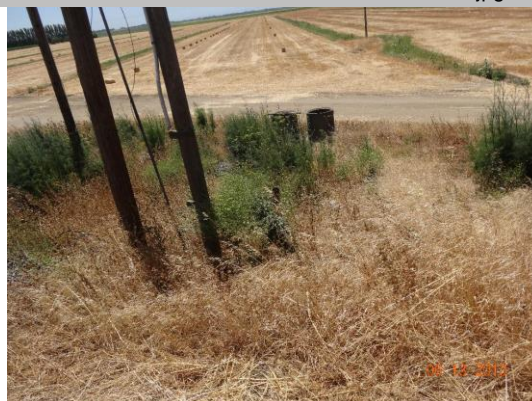
Photo 2 of 3 : UCIP\_FA\_2018\_32544\_59033.jpg

Comment Code						
Inspector Comment						
FS_ID:32544 DS_ID:21060 EP_NO: N/A Repair Type: Non-Urgent Crossing Status: Found UCIP Comments: Dense vegetation limits the inspector's visibility to identify signs of pipe failure (leaks) along the slope. Recommend removing vegetation along pipe alignment to conduct proper inspection of structure and appurtenances. Walkway missing but platform remain on the waterward side. FIELD_STRUCT_DESC: 12-inch irrigation discharge pipe of an unknown material through the levee, 6.5 feet below the crown. Switch panel on the waterside (WS) slope. Pump on a pile structure in the stream. [Additional Reference(s): DWR Levee Log, 2005. USACE Sacramento O&M Manual 105, April 1959, (HLM 7.3)]. FS Date: 6/13/2013

View of standpipes located on landward side.

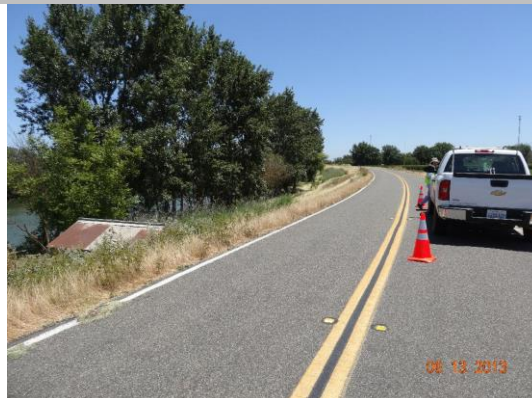
Photo 1 of 3 : UCIP\_FA\_2018\_46834\_33471.jpg

Overview of levee crown.

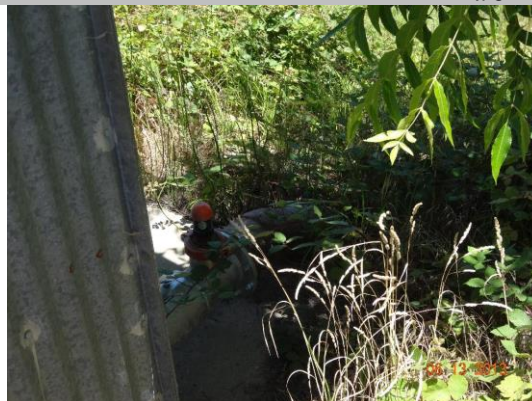
Photo 2 of 3 : UCIP\_FA\_2018\_46834\_33468.jpg

Pipe connection after pump station.

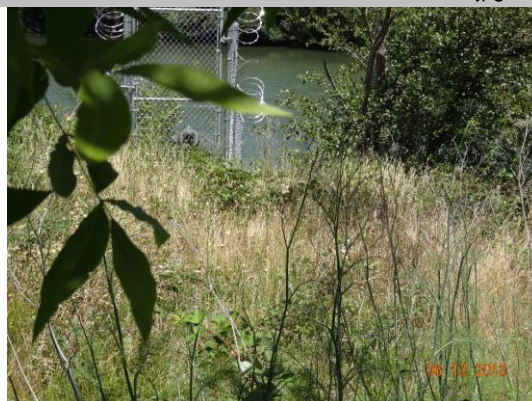
Photo 3 of 3 : UCIP\_FA\_2018\_46834\_33467.jpg

Comment Code						
Inspector Comment						
FS_ID:46834 DS_ID:21061 EP_NO: N/A Repair Type: Non-Urgent Crossing Status: Found UCIP Comments: 11/19/2015 DWR Inspector (H. Phillips) coordinated with LMA superintendent and the owner for this crossing is Walter Koeing, APN No. 042220040. According to LMA superintendent owner installed filter system with fence on landward side and fence around pump in 2012. Pipe not replaced in 2012, this pipe would be a good candidate for internal inspection since the installation date for this crossing was recorded as 1946.06/13/2013 Conduit visible on landward side; new gate on WS toe; filtration system with security fence; Pipe has been upgraded--need permit authorizing work and owner. Dense vegetation limits the inspector's visibility to identify signs of pipe failure (leaks) along the waterward slope. Recommend removing vegetation along pipe alignment to conduct proper inspection of structure and appurtenances. FIELD_STRUCT_DESC: 8-inch steel irrigation discharge pipe through the levee, 3.7 feet below the crown. Siphon breaker and service pole on the landside (LS) slope. 2-inch electrical conduit of an unknown material runs parallel to the 8-inch steel pipe. Pump in a pump house on the waterside (WS) slope. [Additional Reference(s): DWR Levee Log, 2005. USACE Sacramento O&M Manual 105, April 1959, (HLM 8.0)]. FS Date: 6/13/2013

Pipe section near toe is protected by security fence.

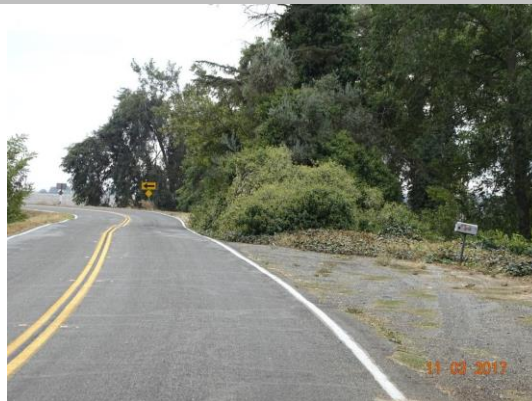
Photo 1 of 1 : FA\_2018\_RD0501\_171\_42\_20180925\_00011.jpg

LM Start	7.55	Rating **	U	Issue No.	42
LM End	7.55	Issue Type +	En	Location *	LS
Category	Earthen Levee			GPS Latitude/Longitude	
				Start	End
Item	Vegetation			38.286653 °	38.286653 °
				-121.608417 °	-121.608417 °
DWR ID	DWR_RD0501_03_f_2017_42				
Comment Code					
V6 : Landscaping					
Inspector Comment					
Remove/thin landscaping to allow inspection and access to landside slope and toe.

Remove/thin landscaping to allow inspection and access to landside slope and toe.
